RDT&E Project No. Not Available  
USATECOM Project No. 1-6-4030-12  
Report No. DPS-2309

FINAL REPORT ON  
PRODUCT IMPROVEMENT TEST  
OF  
TRUCK, UTILITY, 1/4-TON, 4X4, M151, MODIFIED  
WITH SOLID REAR AXLE  
BY  
C. M. BRYZEK, JR.  
MARCH 1967

12 APRIL THROUGH 30 DECEMBER 1966

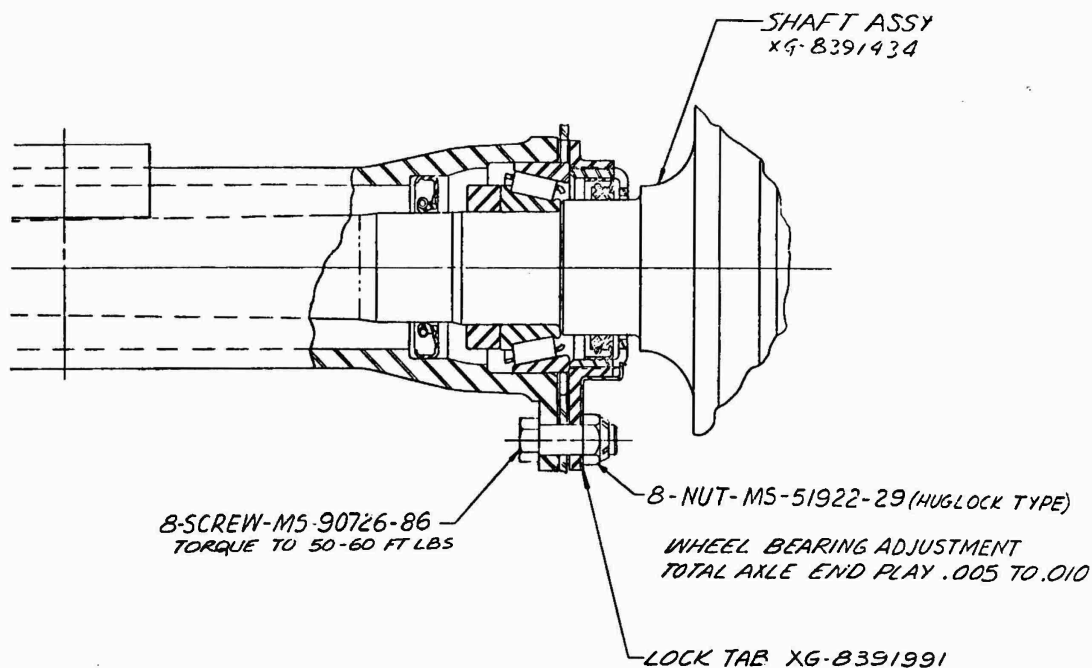
Figure 2.11-5: Axle-Shaft Assembly.

2.11.3.5 Group 11, Rear Axle. During operation, the rear differential lost lubricant through the differential carrier vent, at the rivets which attach the brake tube bracket to the carrier. After replacement of the vent at 6004 test miles, loss of lubricant through the vent was reduced. However, after 400 miles of operation, it was found that gear oil had been forced past the axle shaft inner seals and was contaminating the lubricant of the rear wheel bearings.

In accordance with directions from ANICPM-GP-TI (Appendix III), rear wheel bearings were not repacked at the normal 12,000 mile interval. However, after 17,801 test miles, rear-differential lubricant was leaking past the left and right rear-axle seals and wheel-bearing outer seals into the brake cavities. Replacement of the rear-axle wheel-bearing outer seals or repacking the bearings required an excessive amount of maintenance time, since the retaining collar must be broken and then the bearing must be pressed off the shaft (Figure 2.11-5). Extreme care must be exercised when pressing the bearing off and on the shaft to prevent bearing damage.
